**CLEAN OIL
BRIGHT IDEAS**

Turbine Lube Oil Electric Power Plant, Gas Turbine

CJC™ Application Study

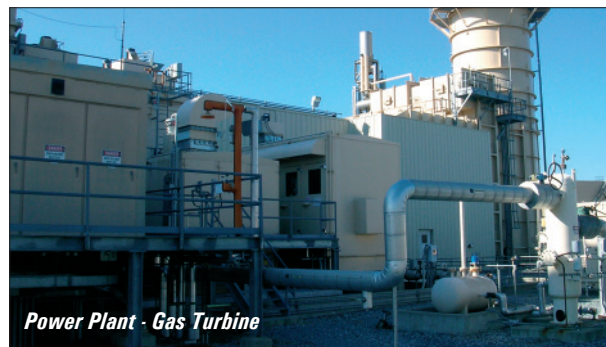
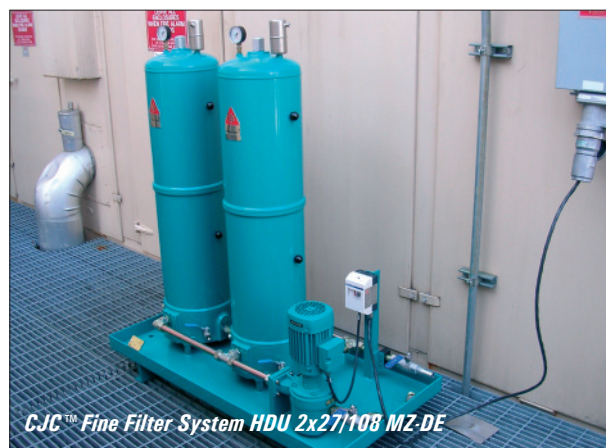
Oil samples were taken prior to installation and sent to an independent oil analysis laboratory for testing. Regular samples were taken and the results compared. A sub micron particle count was the key test since varnish particles are typically 0.2 - 2 µm.

The turbine operated 9 hours from December through May. The minimal run time allowed the CJC™ Fine Filter to clean the oil in the reservoir many times over, polishing the oil. During the month of June the turbine run time increased by 250 hours allowing the ultra clean oil in the reservoir to circulate throughout the turbine lube oil system. As a result, the ultra clean oil acted as a solvent, removing oxidation deposits from internal surfaces. This caused a surge in sub micron particles. Continuous filtration with the CJC™ Fine Filter significantly lowered the high level of particles before the end of June.

The varnish level was reduced as observed in the sub micron particle count and the entire lube system was cleaned. More importantly, a reduction in unit trips was observed and recorded.

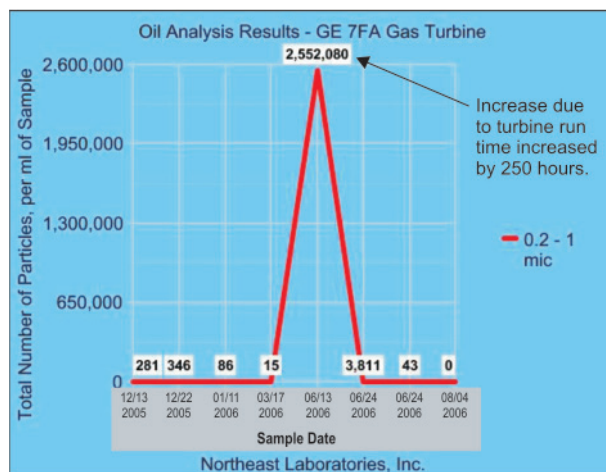
OIL SAMPLES

Varnish Potential Test

Before: 40 Color Value

After: 8 Color Value
